REPORT NO. 3149870CRT-001

TEST OF 92 SERIES LED 360° WARNING LAMP

TRUCK-LITE CO., INC.  
310 E ELMWOOD AVE.  
FALCONER, NY 14733

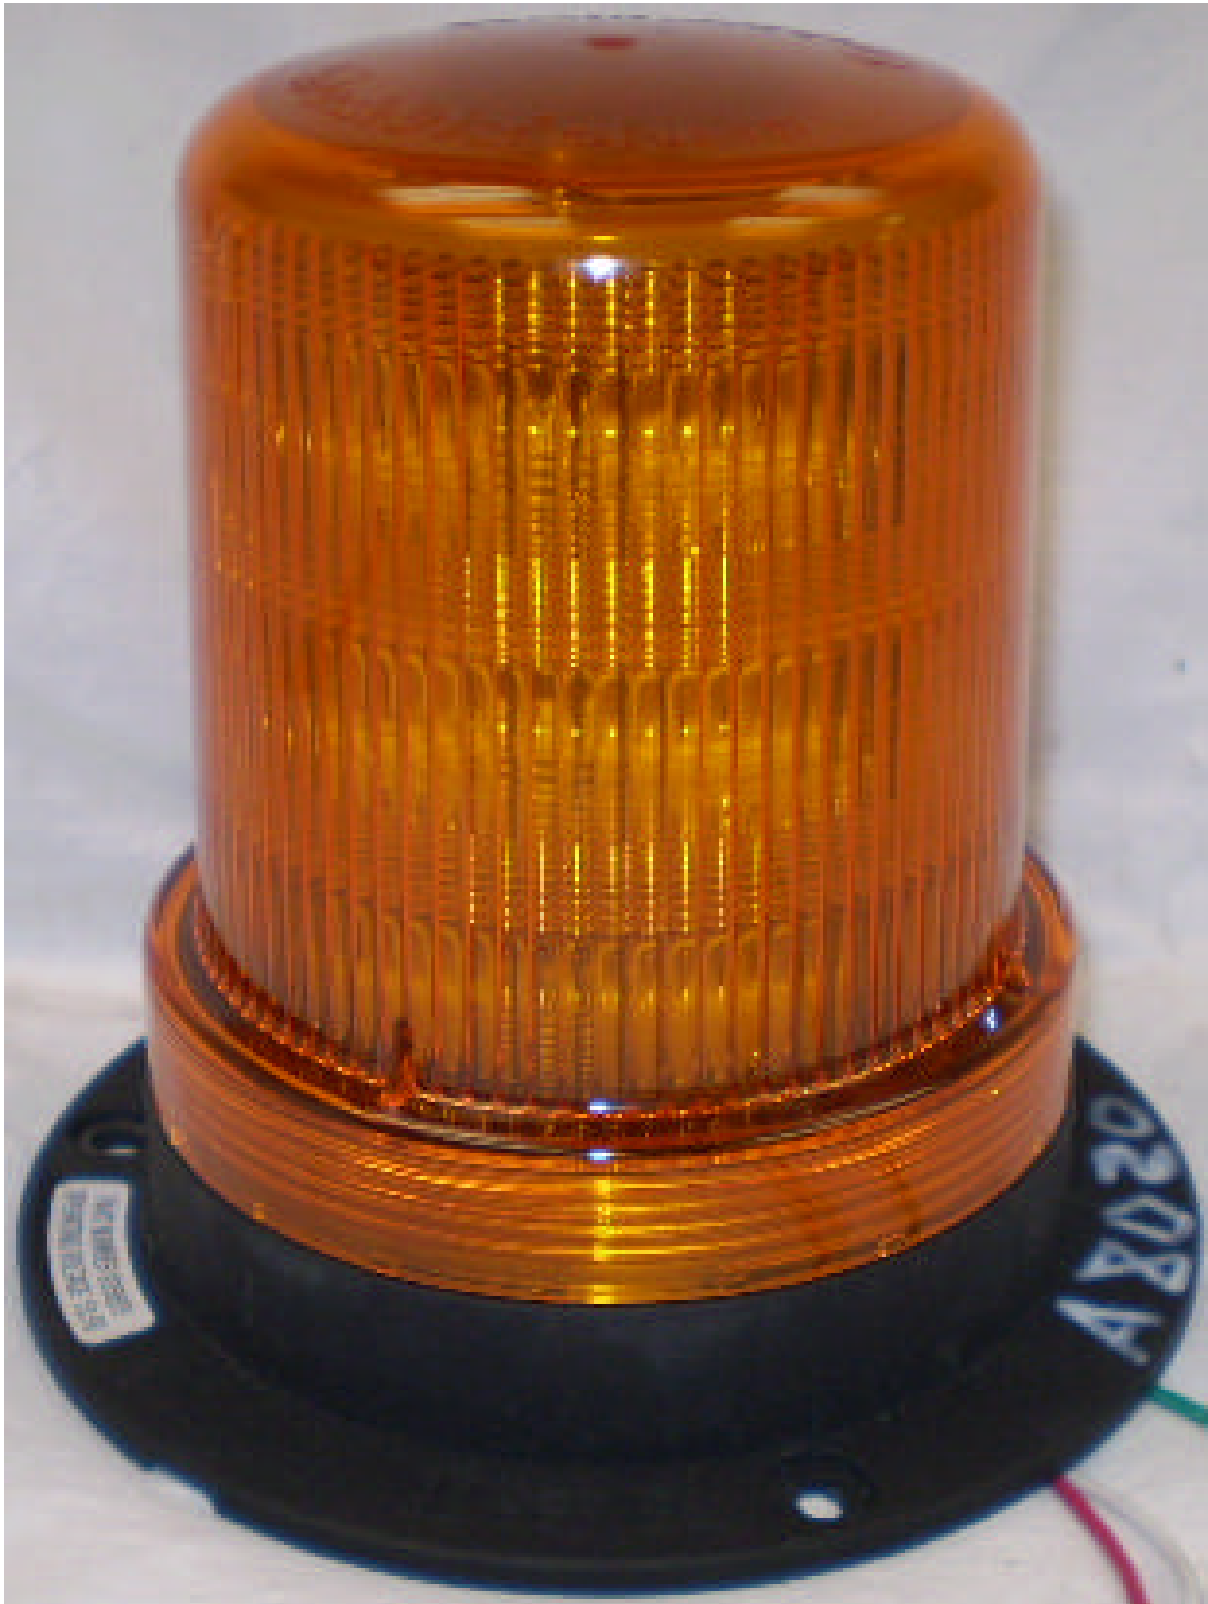
“TEST OF 92 SERIES LED 360° WARNING LAMP”  
TESTED FOR TRUCK-LITE CO., INC.

The 360 degree LED flashing warning lamp consists of an outer ribbed yellow lens screwed to a metal base. The base in turn attaches to the vehicle with three screws. The LEDs are arranged in six columns of 3 stacked LEDs, with each LED having a clear plastic lens in front of it. The metal base has a pipe mount capability. All tests were conducted with the lamp operating at 12.8 volts. No lens plastic material information or light source information was supplied. The markings are listed below. Please see pictures.

- On lens: "Truck-Lite SAE W3-107", twice, in raised molded lettering
- On base: "Truck-Lite 92 SERIES" in raised molded lettering
- On sticker: "PART NUMBER 95565Y OPERATING VOLTAGE 13.5" in black inked lettering on a silver sticker

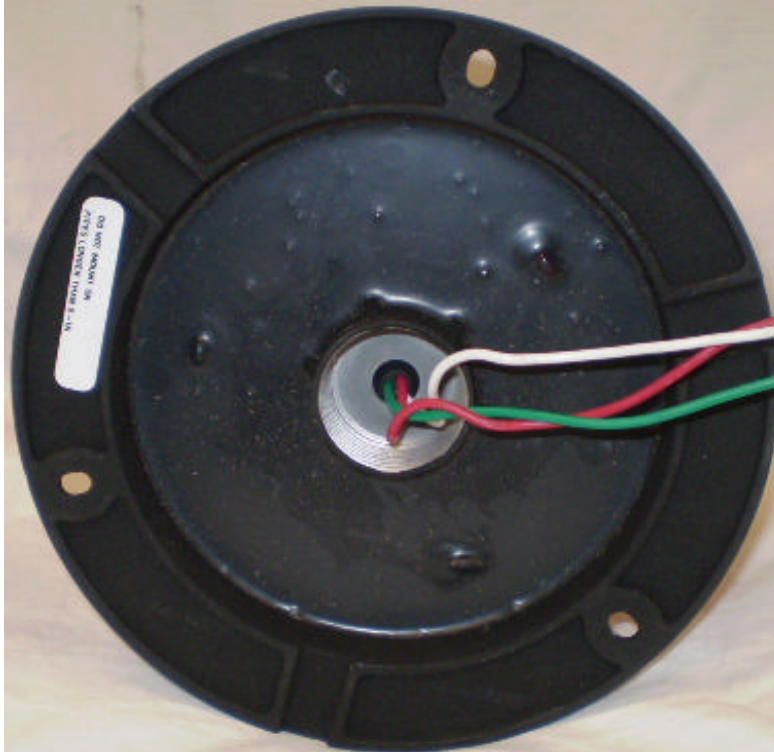
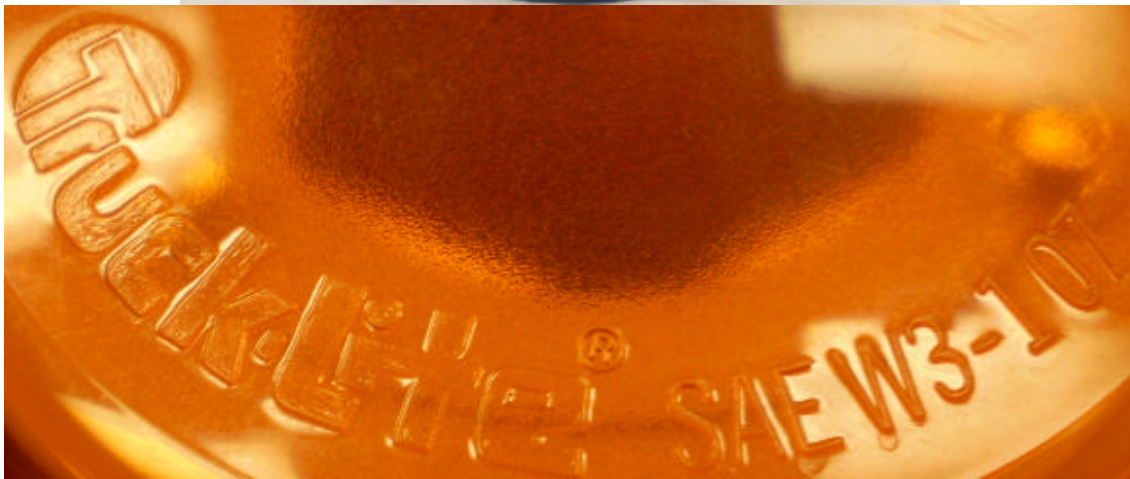
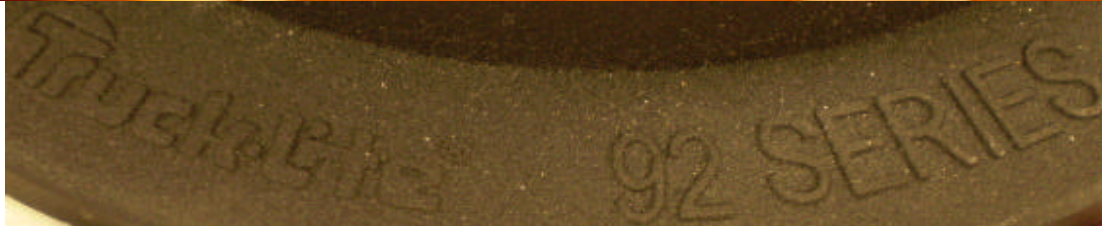
“TEST OF 92 SERIES LED 360° WARNING LAMP”  
TESTED FOR TRUCK-LITE CO., INC.

PART NUMBER 92565Y  
OPERATING VOLTAGE 13.5V
